USAAMRDL TECHNICAL REPORT 71-34

**THREE-AXIS FLUIDIC STABILITY AUGMENTATION
SYSTEM FLIGHT TEST REPORT**

EUSTIS DIRECTORATE
U. S. ARMY AIR MOBILITY RESEARCH AND DEVELOPMENT LABORATORY
FORT EUSTIS, VIRGINIA

CONTRACT DAAJ02-70-C-0017
HONEYWELL, INC.
MINNEAPOLIS, MINNESOTA

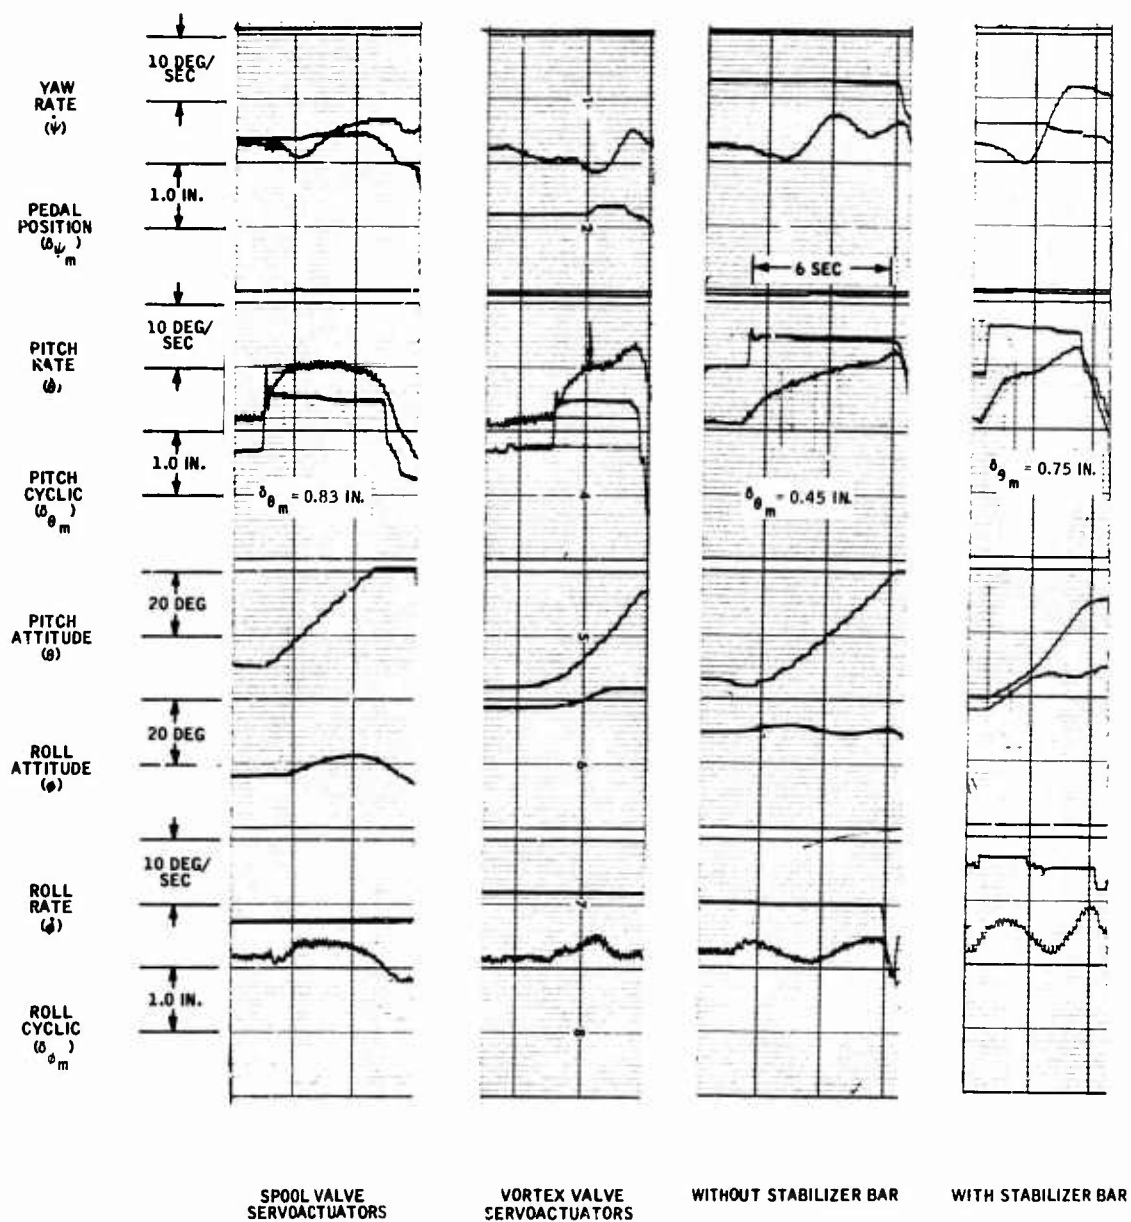
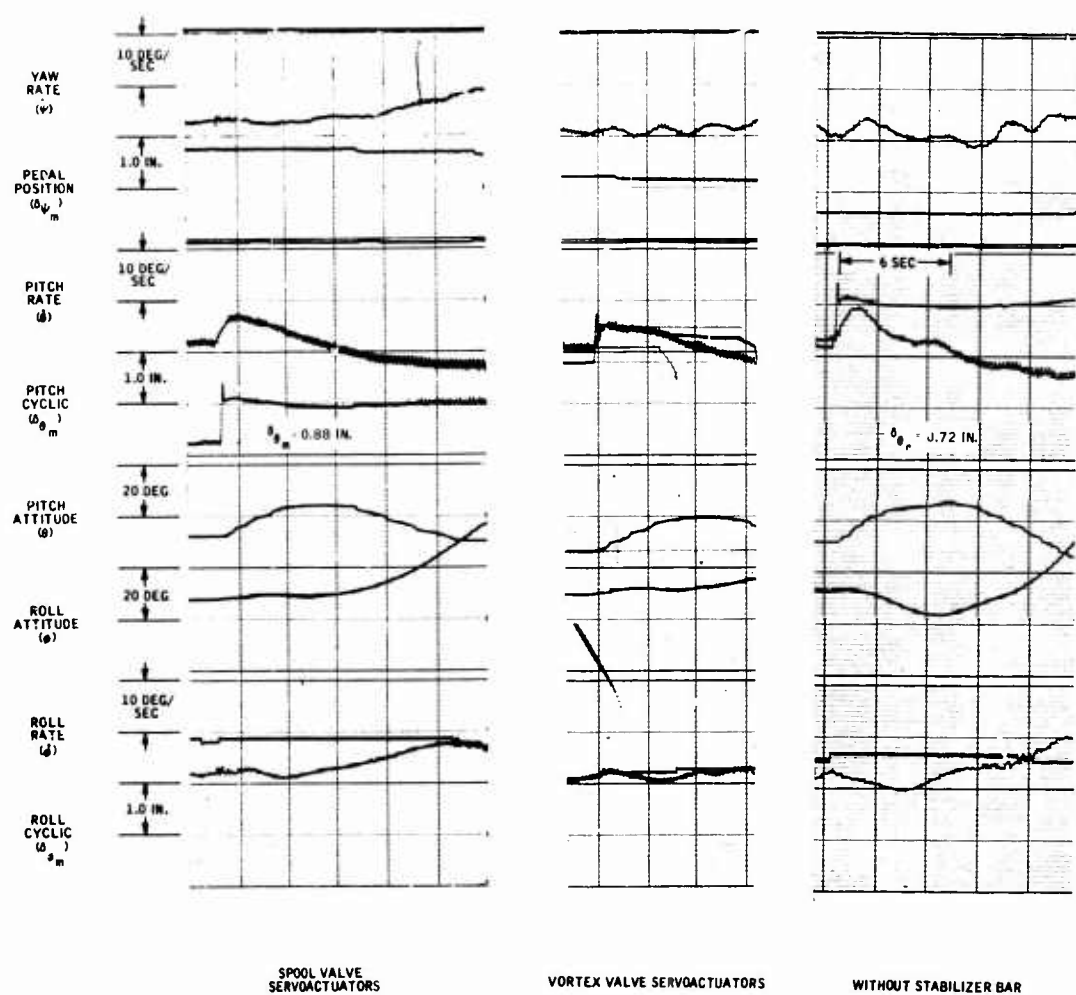
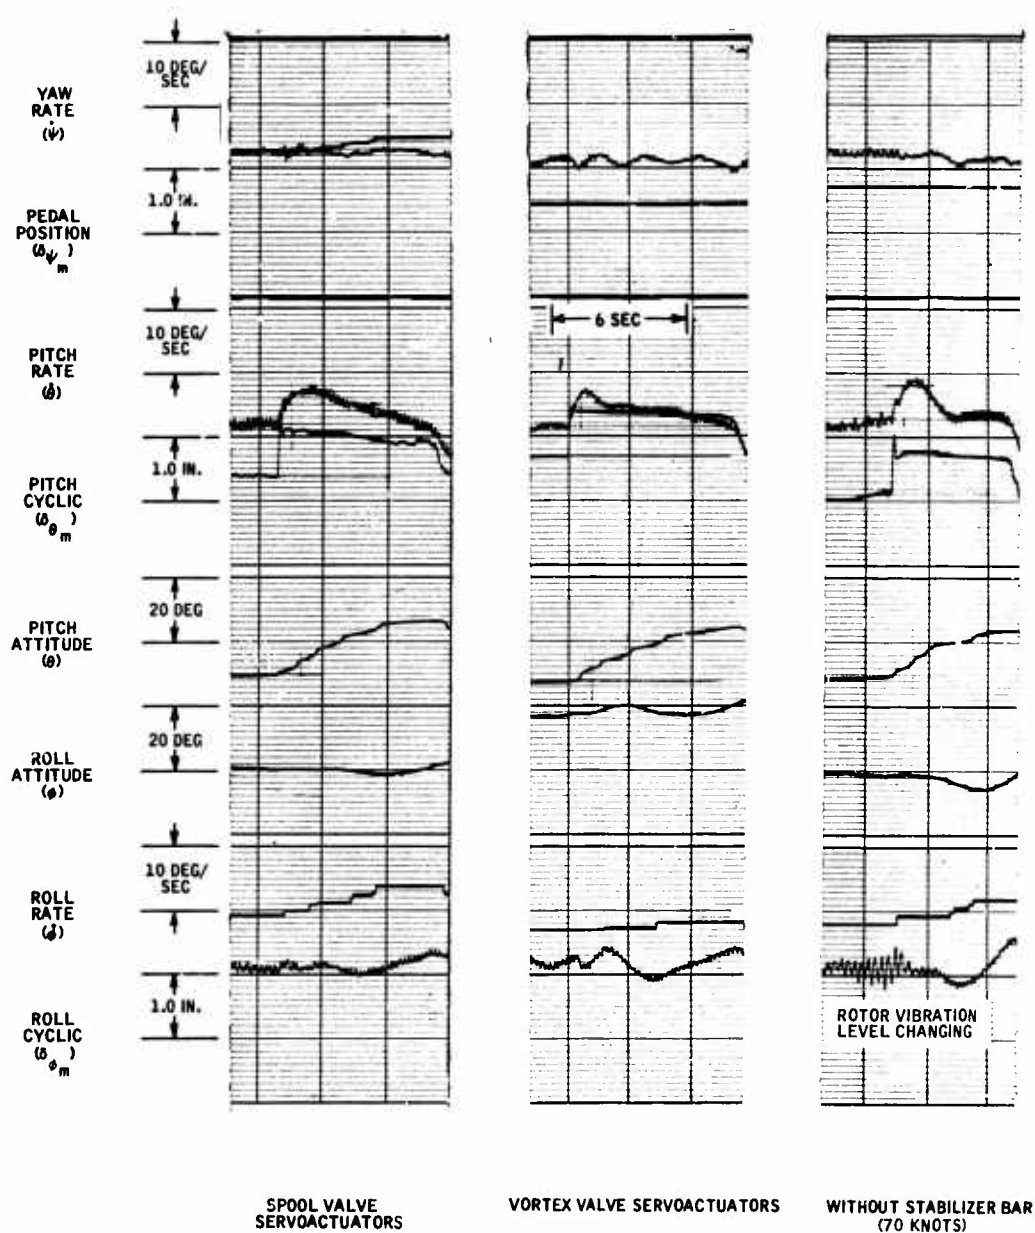
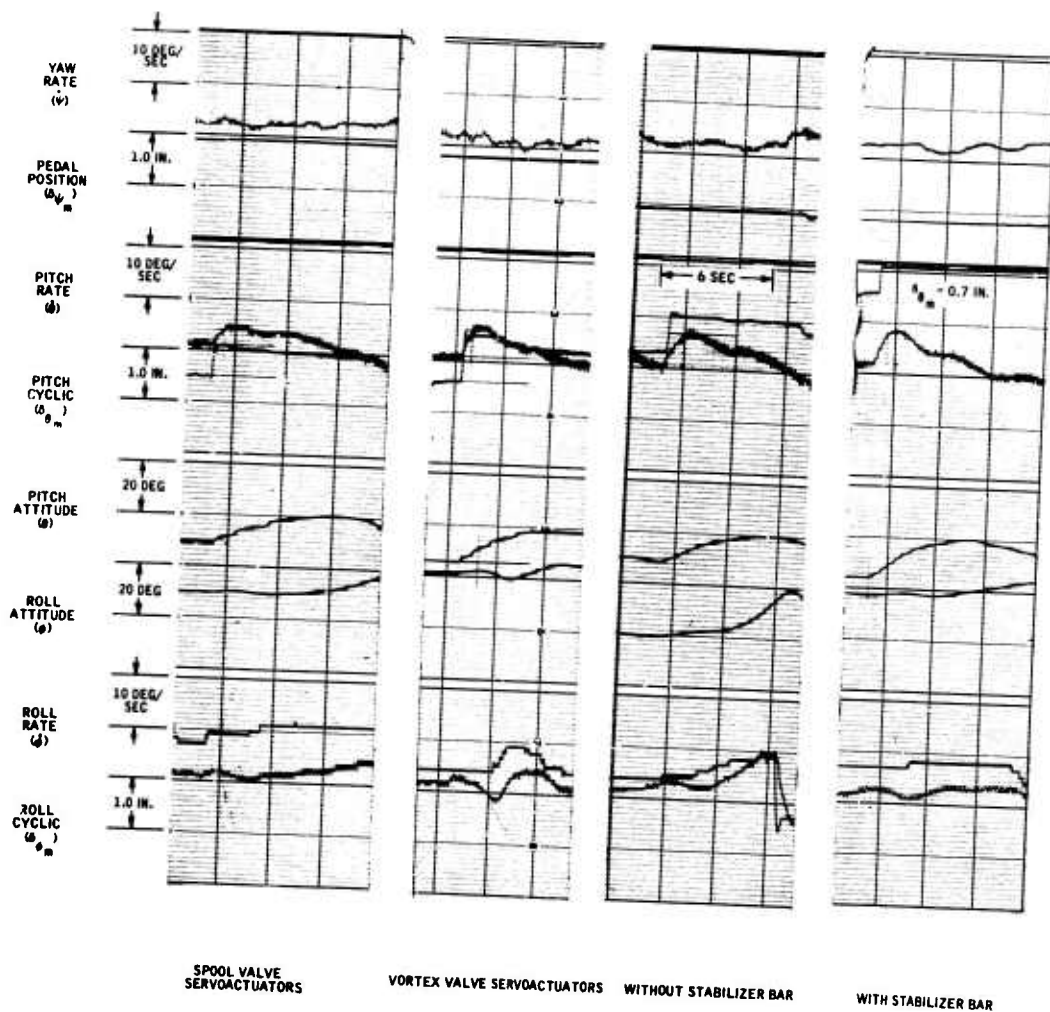
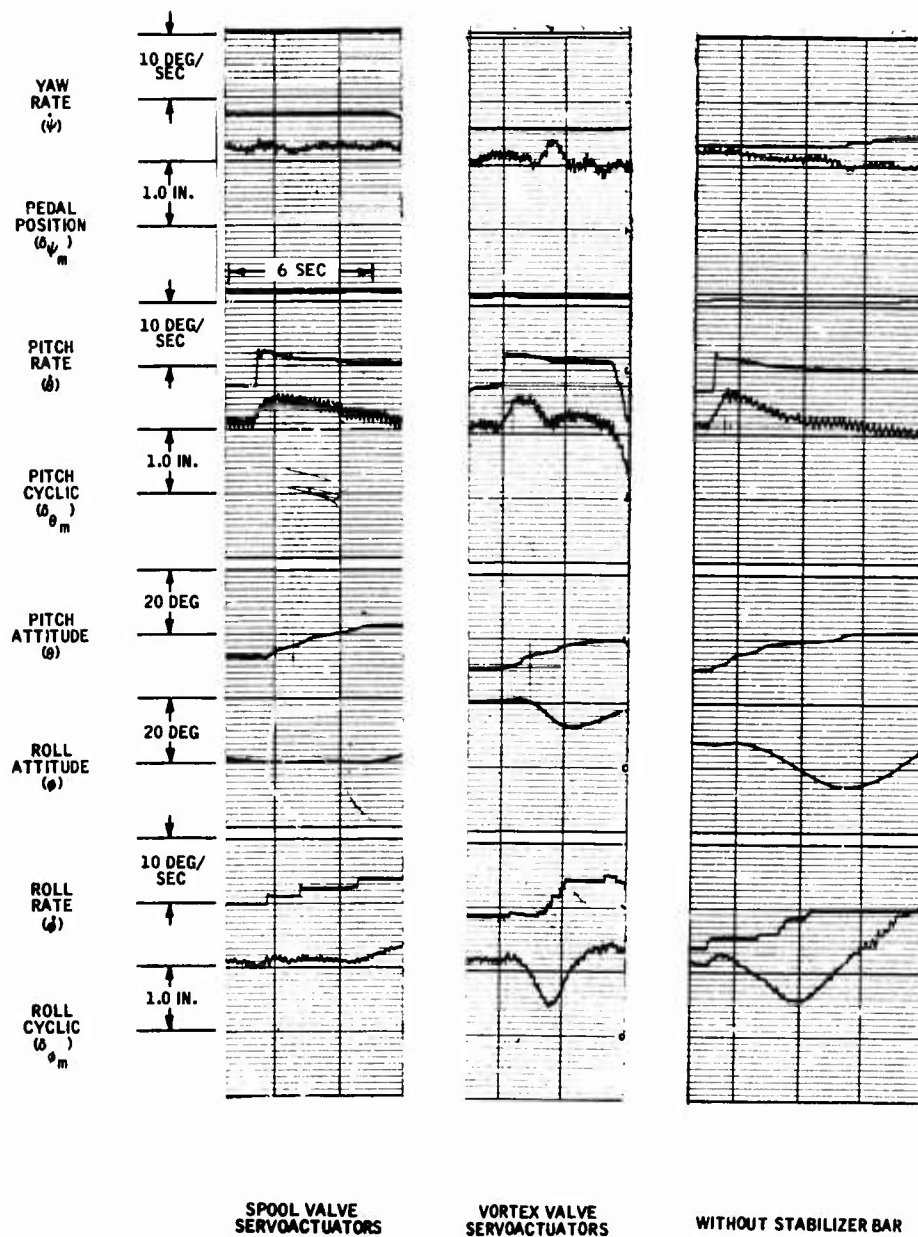
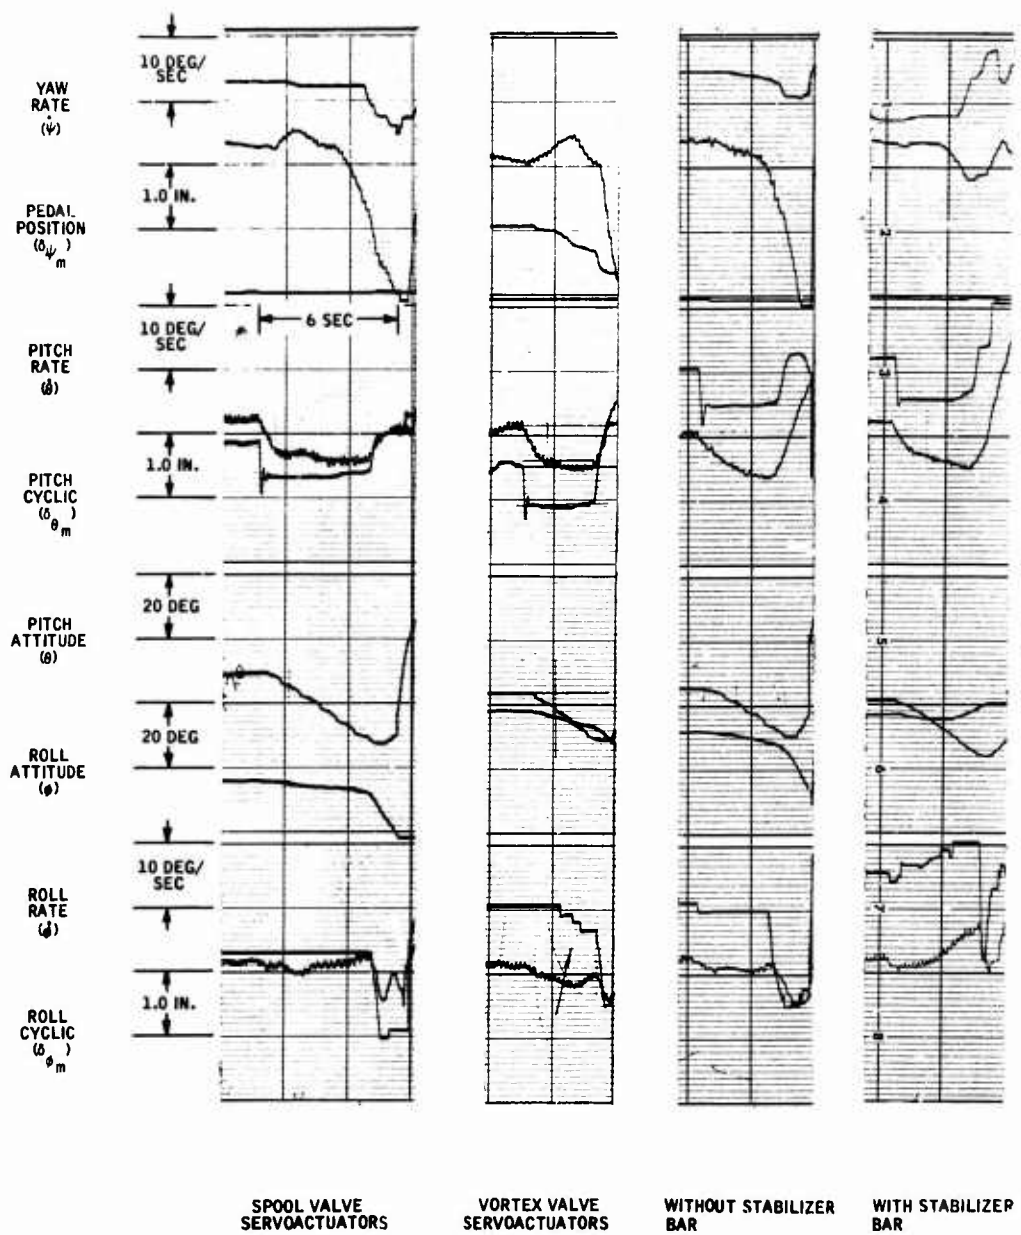
Flight recordings showing FSAS with vortex valve servoactuator response to pitch cyclic step input commands are presented in Figures 74 through 83. These recordings show that at some flight conditions the FSAS had very little effect on the shape of the helicopter's short-term response. This can be seen by referring to Figures 74, 76, 77, 78, and 82. On the other hand, at other flight conditions the vortex valve servoactuators were effective in changing the unaugmented helicopter's peak rate response to rate response proportional to cyclic inputs. Examples of this desired performance are shown in the recording of Figures 75, 80, and 81. This nonrepeating performance is due to the vortex valve servoactuator threshold problem previously discussed.

- Yaw step - right (Figures 44 through 48)
- Yaw step - left (Figures 49 through 53)
- Yaw pulse - right (Figures 54 through 58)
- Yaw pulse - left (Figures 59 through 63)
- Roll step - right (Figures 64 through 68)
- Roll step - left (Figures 69 through 73)
- Pitch step - down (Figures 74 through 78)
- Pitch step - up (Figures 79 through 83)
- Pitch pulse - down (Figures 84 through 88)
- Pitch pulse - up (Figures 89 through 93)
- Autorotation (Figure 94)

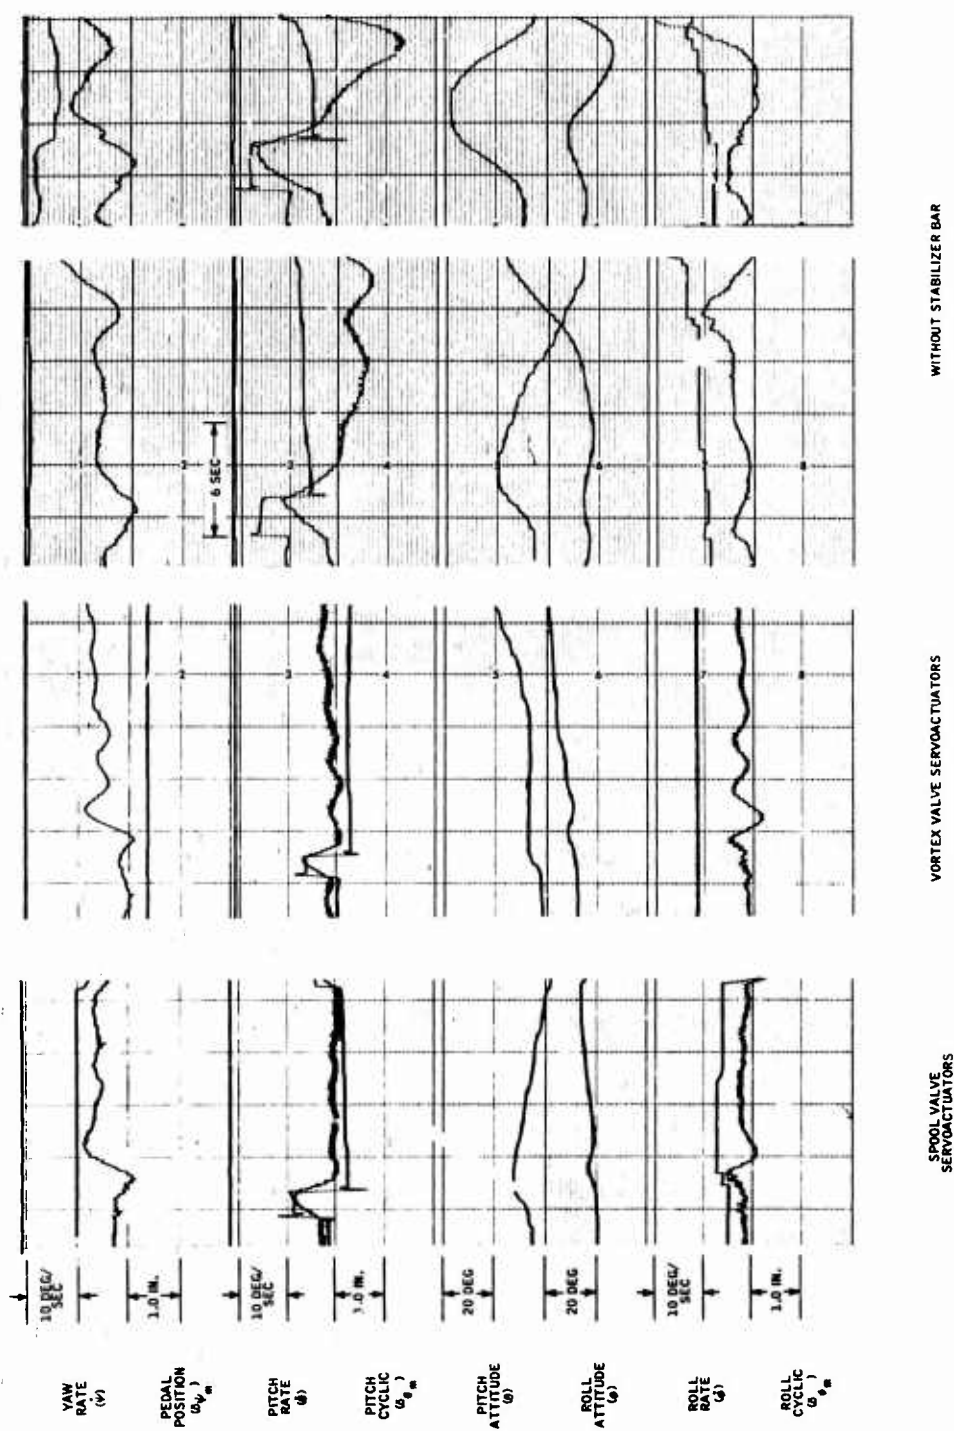
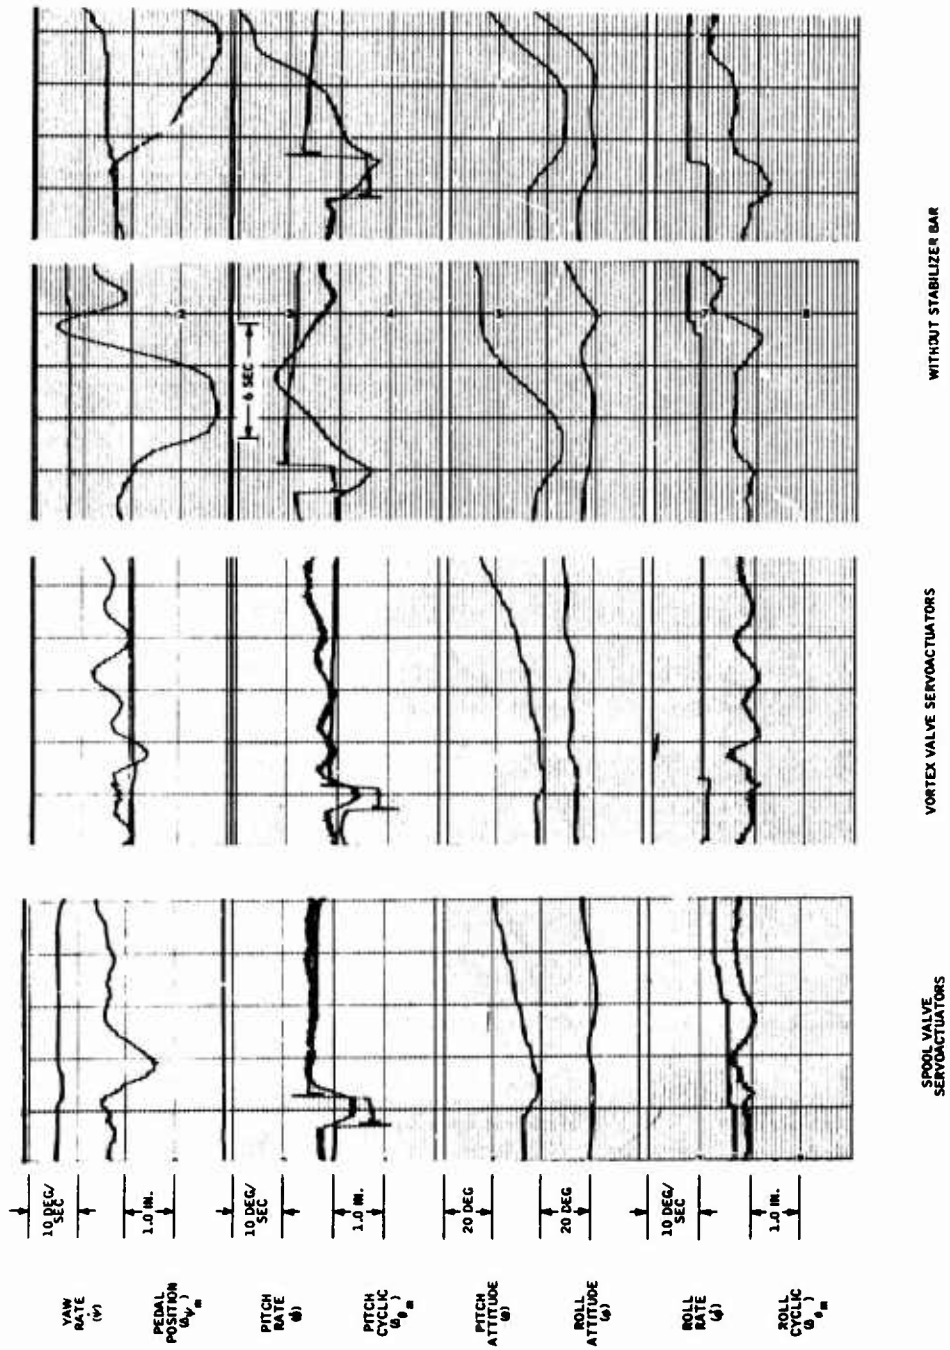
At the hovering flight condition, Figures 84 and 89, a significant improvement in the helicopter's phugoid characteristics is noted. With FSAS disengaged, a pitch-axis disturbance excites the divergent damping phugoid mode which the pilot must overcome to perform a precision hovering task. With FSAS engaged, the hover phugoid mode is stabilized over the short-term control response of the helicopter. Experience with other analysis programs has shown that a near-deadbeat rate response to a longitudinal-axis disturbance is accompanied by a pitch-axis damping ratio of 0.7. (This can be verified by comparing pitch SAS response to a vertical gust, as shown in Figure 98 of USAAMRDL Technical Report 71-30, with those figures referenced above.)

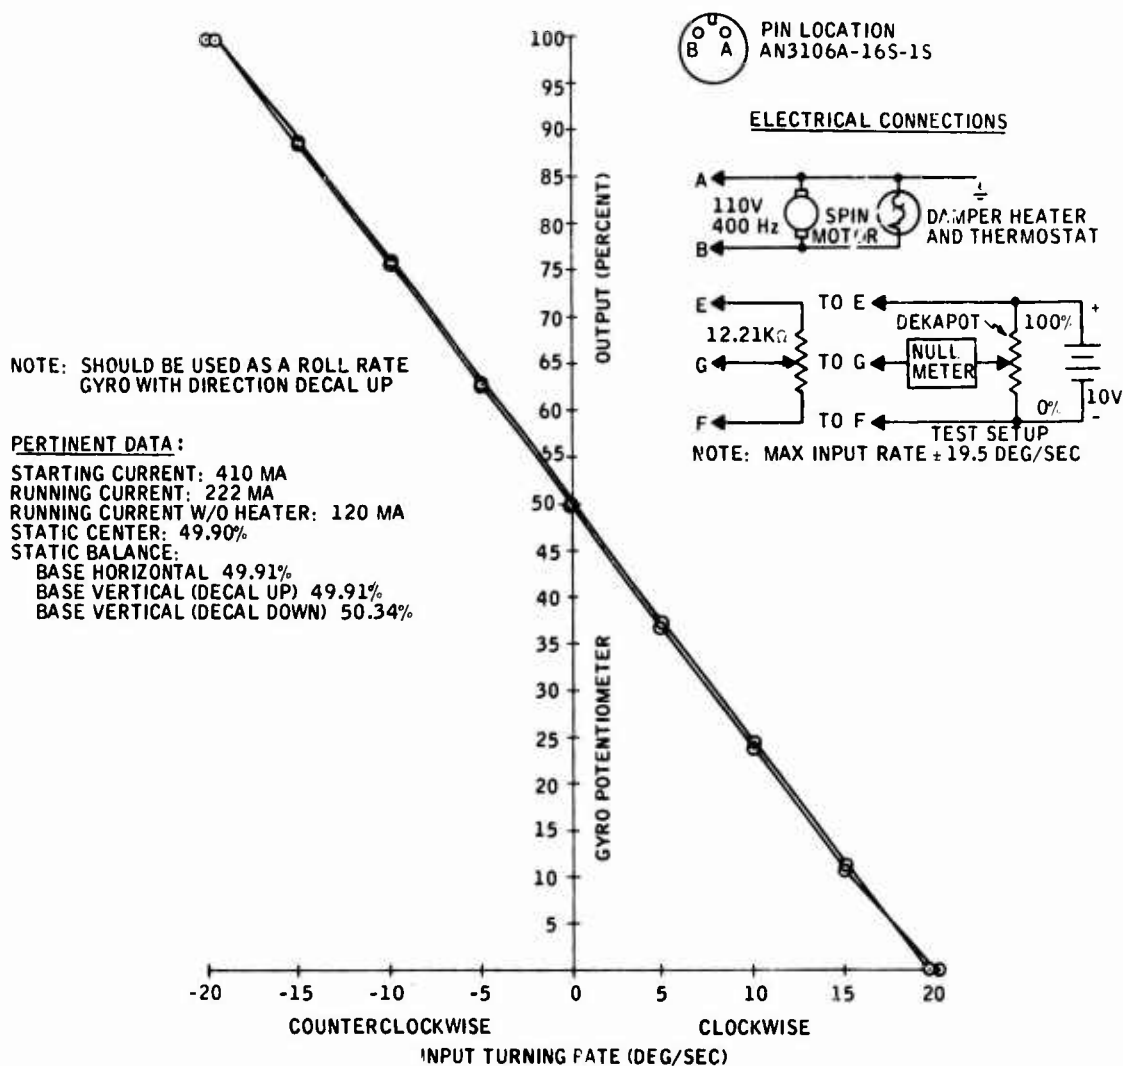
Figure 96. Gyro Output Versus Input Turning Rate for GG79-Type Rate Gyro Used as a Roll Rate Gyro.

RATE OUTPUTS:							
INPUT (DEG/SEC CW)	OUTPUT (%)	INPUT (DEG/SEC CCW)	OUTPUT (%)	INPUT (DEG/SEC CCW)	OUTPUT (%)	INPUT (DEG/SEC CW)	OUTPUT (%)
20	00.00	20	100.00	20	100.00	20	00.00
15	10.88	15	88.77	15	89.35	15	11.43
10	23.96	10	75.80	10	76.38	10	24.58
5	36.82	5	62.70	5	63.35	5	37.40
0	49.80			0	50.18

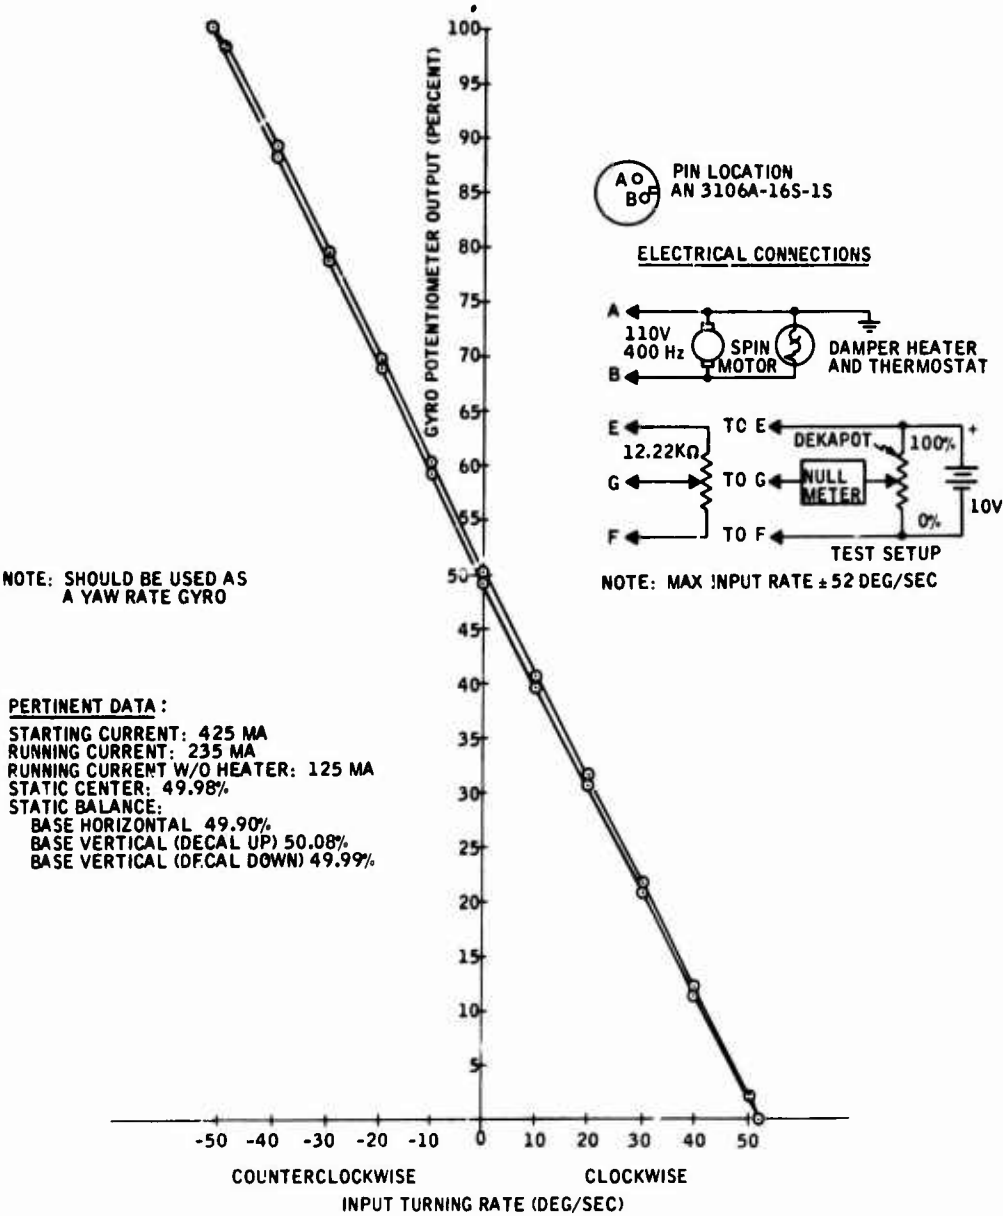
Figure 97. Gyro Output Versus Input Turning Rate for GG79-Type Rate Gyro Used as a Yaw Rate Gyro

INPUT (DEG/SEC)	OUTPUT (%)	INPUT (DEG/SEC)	OUTPUT (%)	INPUT (DEG/SEC)	OUTPUT (%)	INPUT (DEG/SEC)	OUTPUT (%)
50	01.63	50	98.01	50	98.85	50	02.49
40	11.27	40	88.36	40	89.22	40	12.13
30	20.86	30	78.89	30	79.53	30	21.76
20	30.53	20	69.07	20	69.79	20	31.58
10	39.68	10	53.22	10	60.26	10	40.54
0	49.46			0	50.30

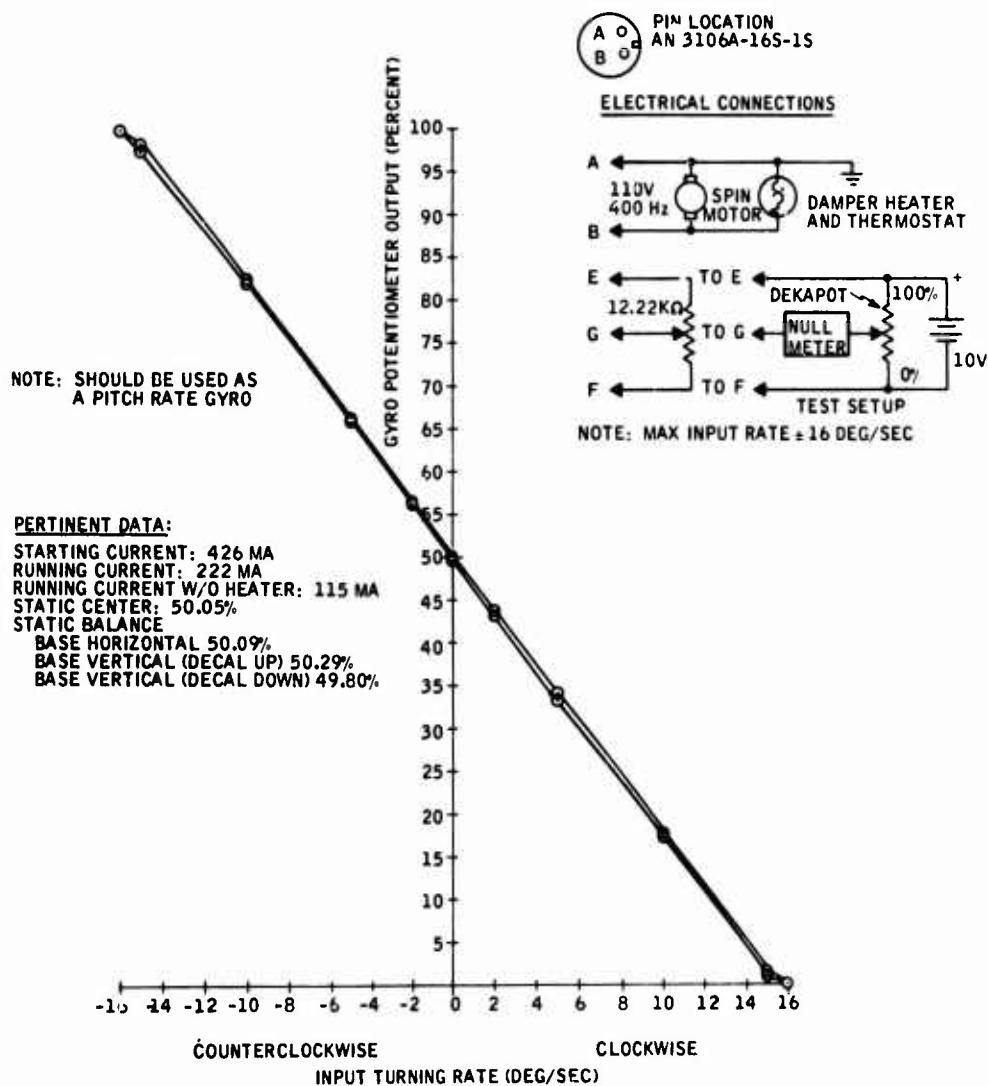
Figure 98. Gyro Output Versus Input Turning Rate for GG79-Type Rate Gyro Used as a Pitch Rate Gyro.

INPUT (DEG/SEC CW)	OUTPUT (%)	INPUT (DEG/SEC CCW)	OUTPUT (%)	INPUT (DEG/SEC CCW)	OUTPUT (%)	INPUT (DEG/SEC CW)	OUTPUT (%)
15	01.00	15	97.76	15	98.17	15	01.79
10	17.33	10	82.03	10	82.48	10	17.73
5	33.23	5	65.79	5	66.41	5	34.15
2	43.14	2	56.35	2	56.69	2	43.87
0	49.78			0	50.20

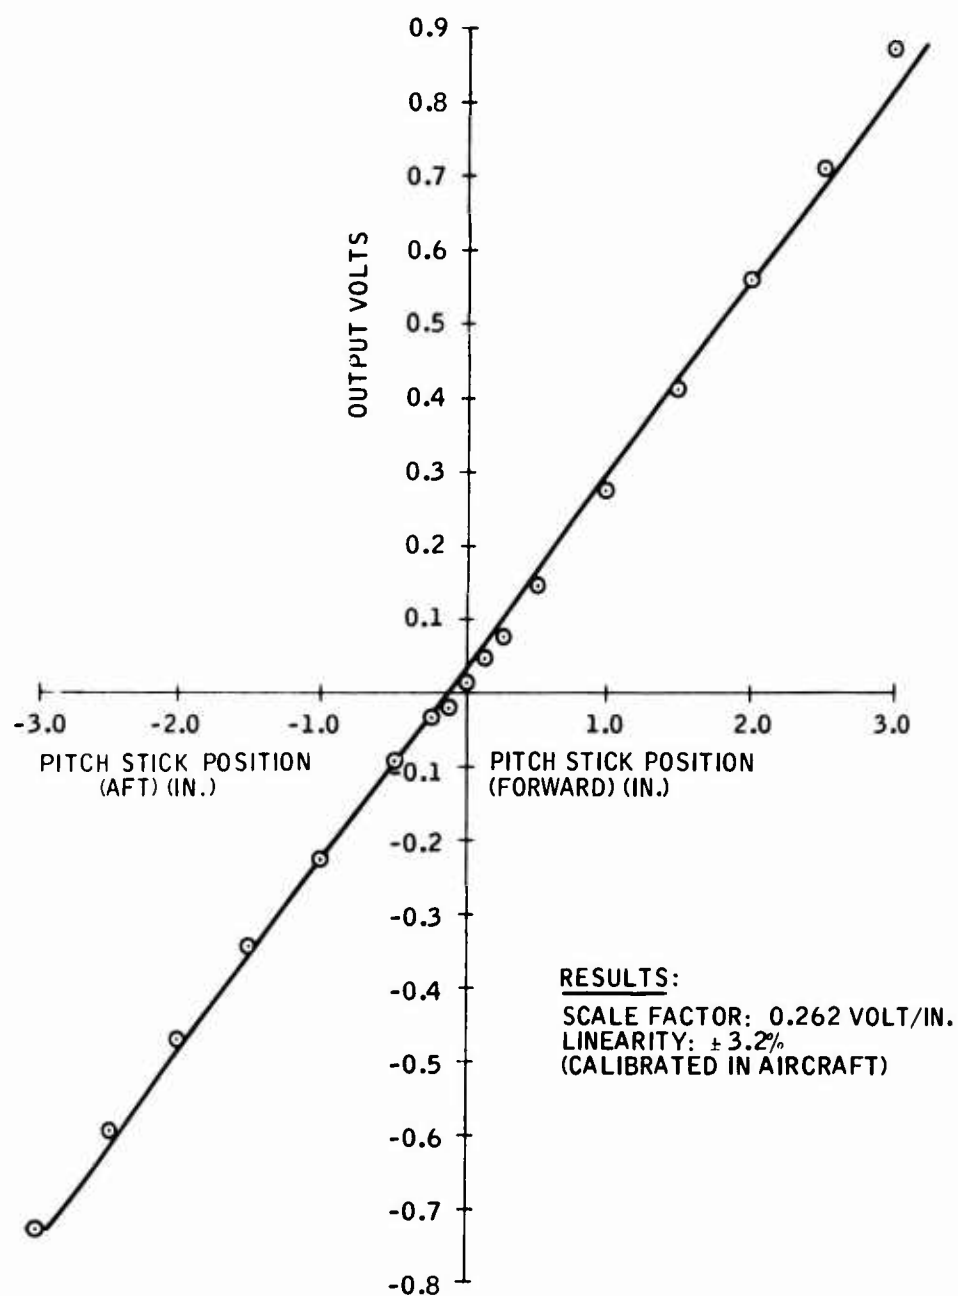
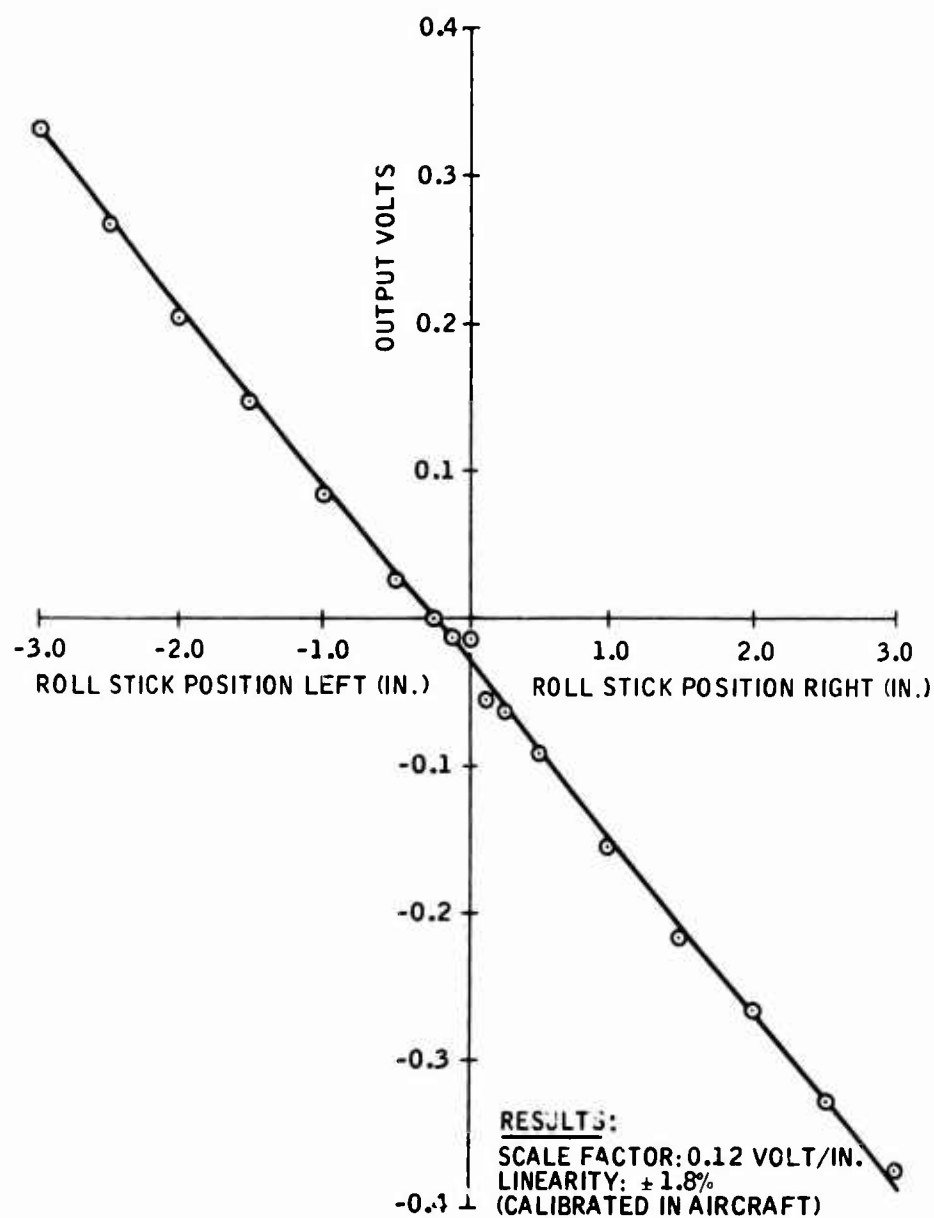
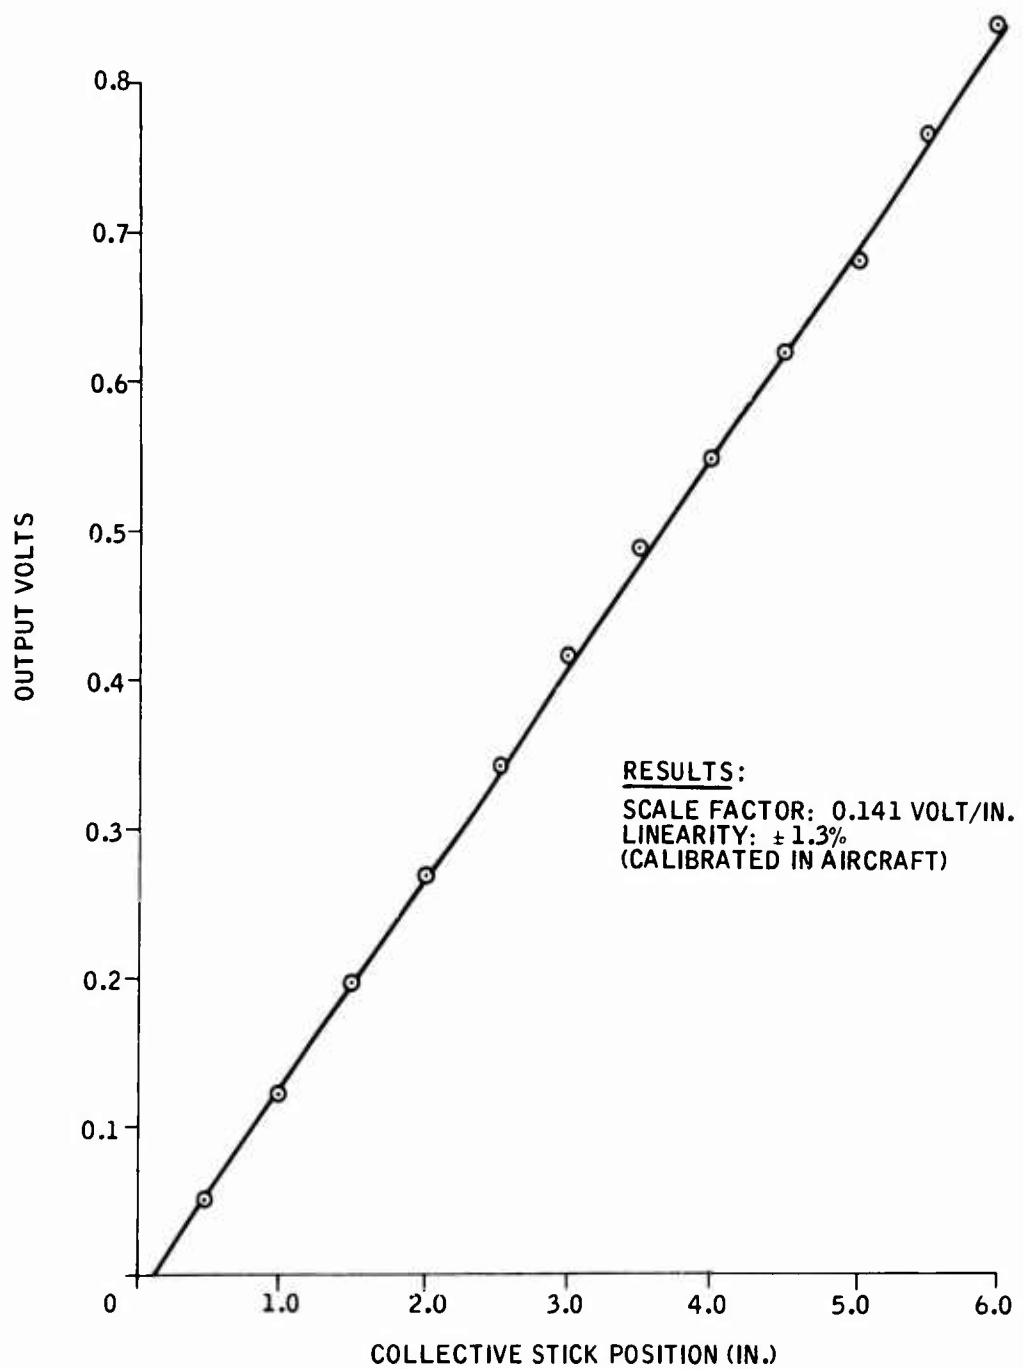
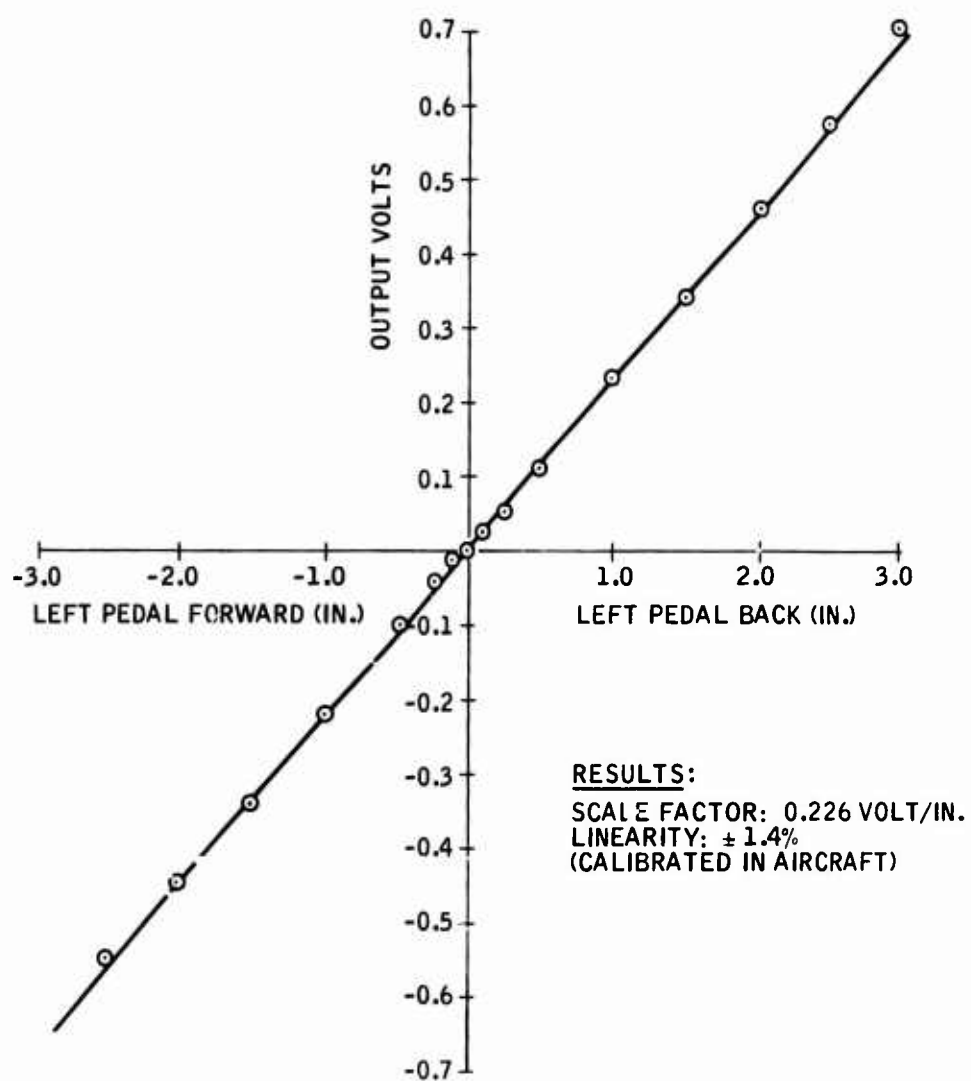
The performance of the four potentiometers used to measure pilot cyclic, collective, and rudder controls is shown in Figures 103 through 106, respectively.
